**CONDITION REPORT**

**ON THE**  
**PASSENGER LIFTS**

**ABBEY & MUNDEN VIEW**

**GARSMOUTH WAY**

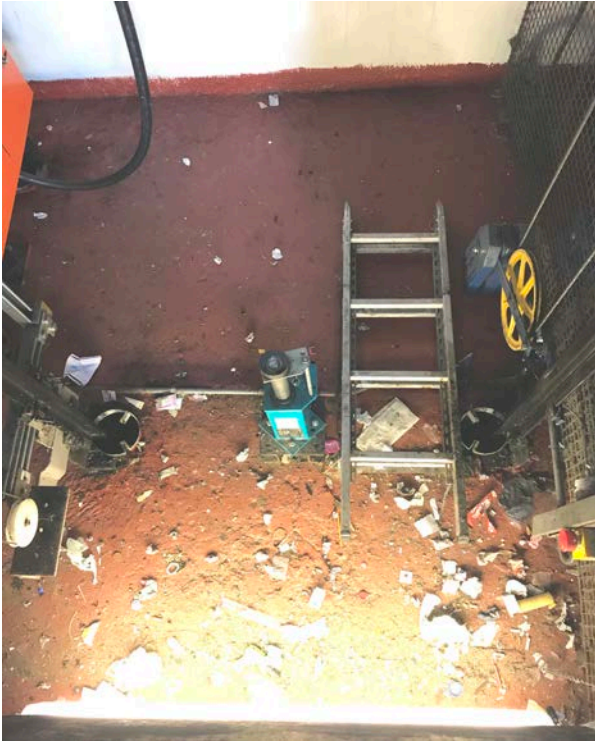
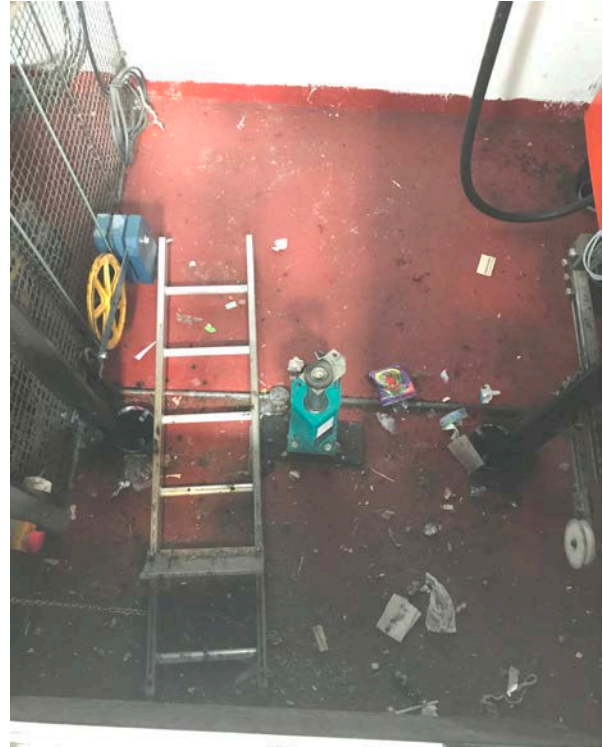
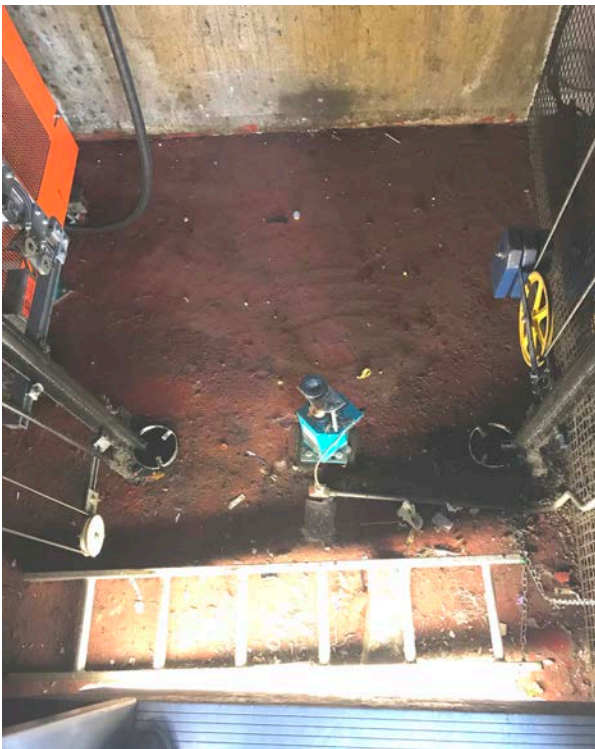
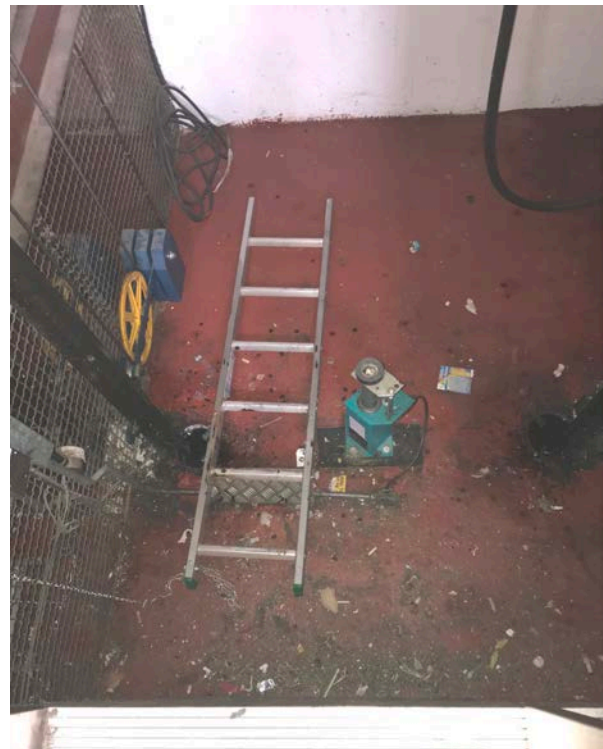
- 3.11 The standard of housekeeping within the lift motor room and lift pit is considered poor but the car top was very clean.
- 3.12 The ride quality and adjustment/operation of the lift car and landing doors was found to be very good.

The standard of housekeeping observed at the time of our survey was found to be poor. All four lifts pit Abbey View (above) and Munden View (below) were begrimed and a considerable amount of rubbish has been allowed to accumulate.

- 5.5 All four lift pits cleaned of accumulated rubbish and overspeed governor tension weights checked and adjusted to ensure correct operation.
- 5.6 New log cards provided to each lift motor room.

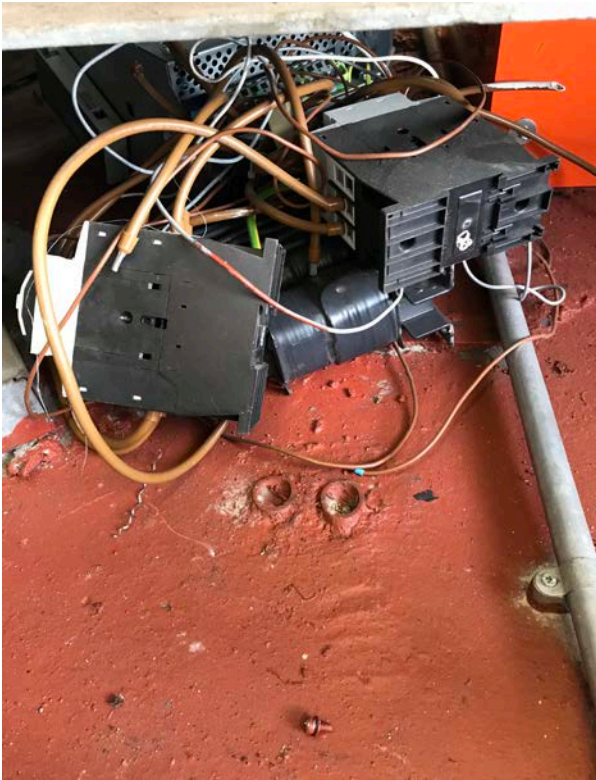
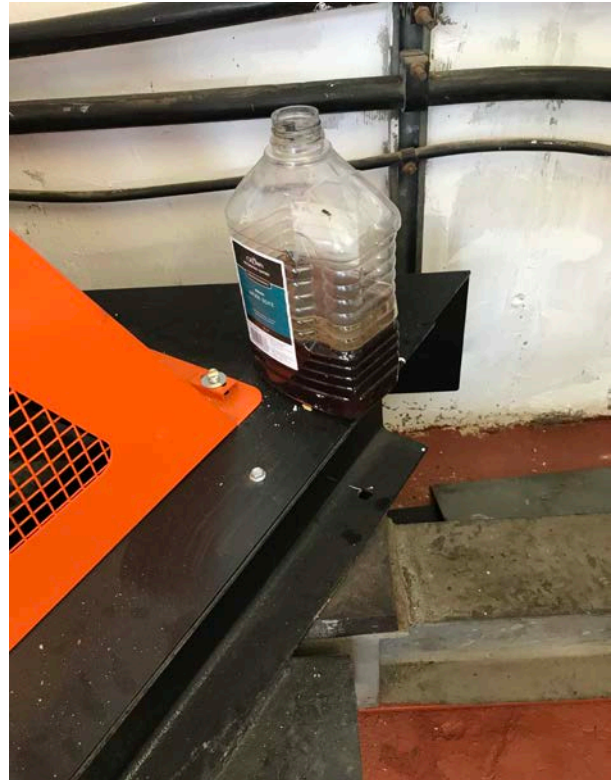
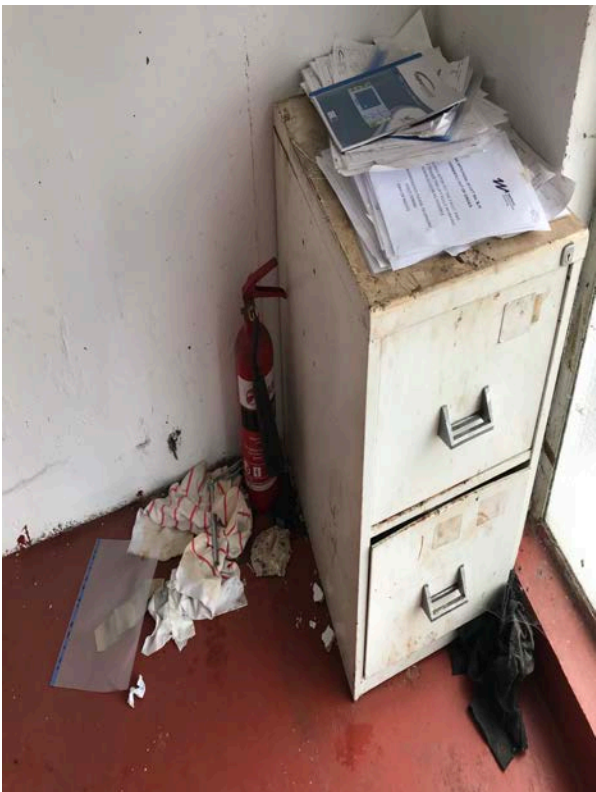
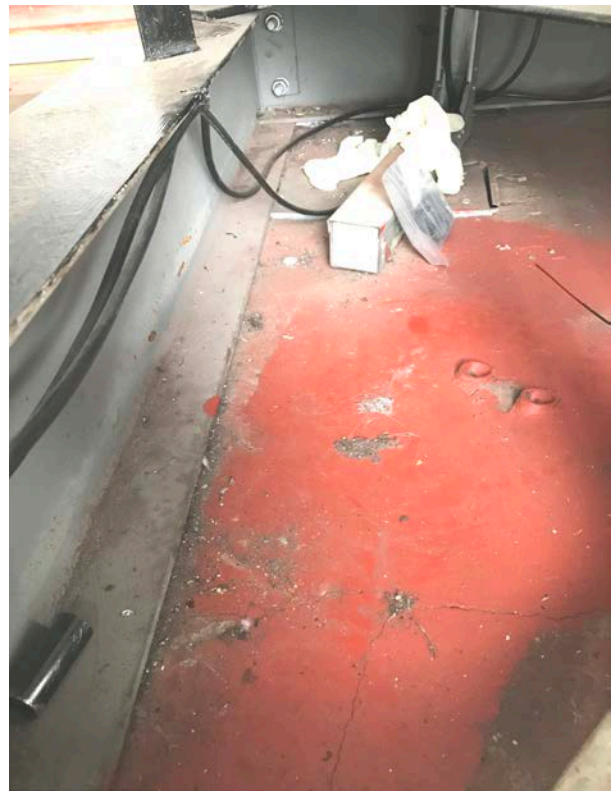
Both lift motor rooms are also in need of cleaning up, components assessed, drawings and documents filed and stored correctly.  
Abbey View motor room above and Munden View below.

- 5.4 Both the lift motor rooms should be cleaned up, drawings collated and stored within the control panels document pockets. All spare component parts assessed for their condition and if deemed to be suitable as replacements stored correctly.

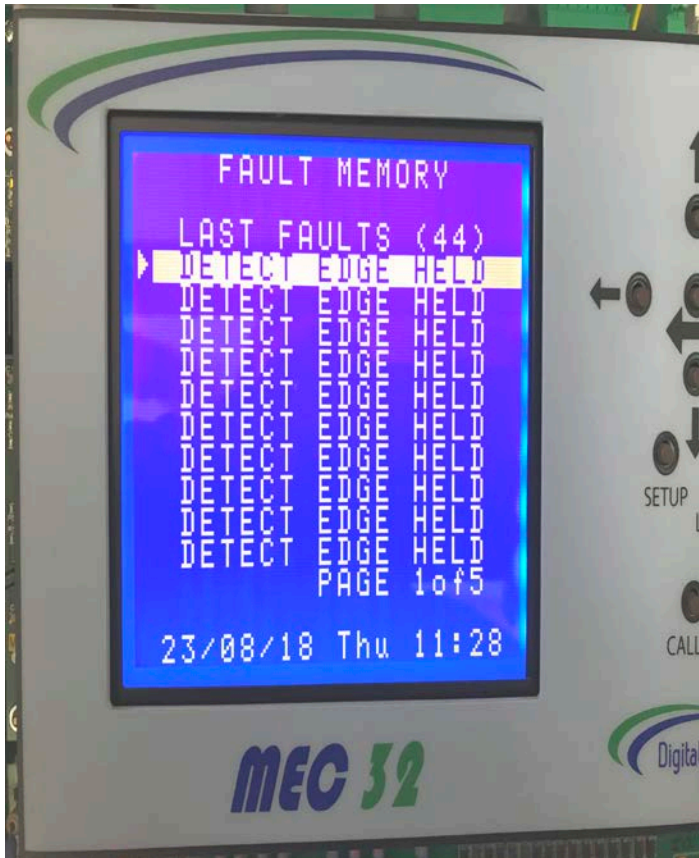
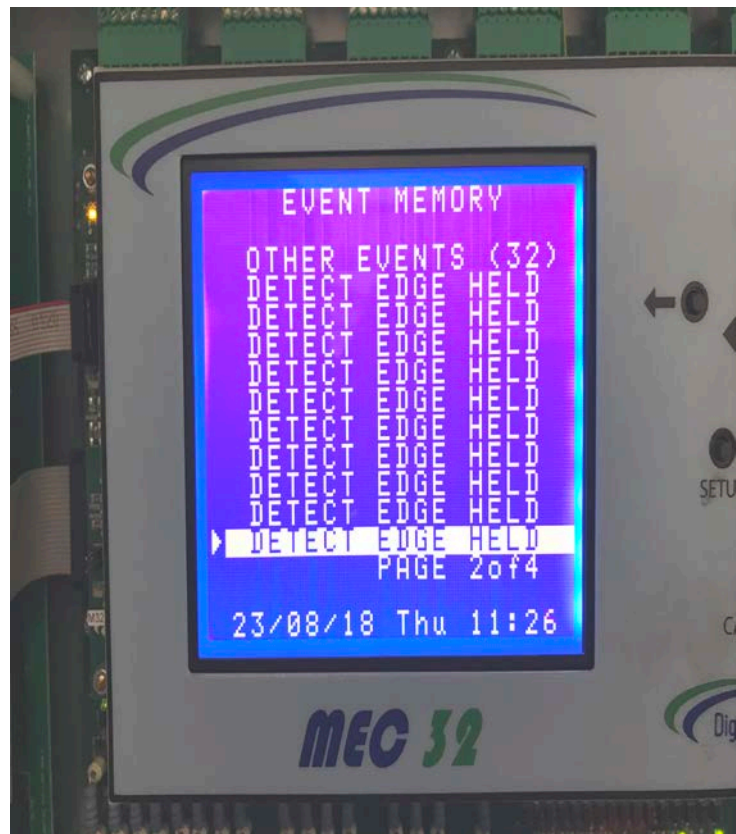
An example of the 'Fault' log memory that can be interrogated further to establish the floor level the fault was registered at.

The 'Event' memory is similar to the fault log but monitors additional 'events' that result in a fault being registered.

Reference between the two screens assists with diagnosing if there were any additional control or operational issues that caused the 'fault'.

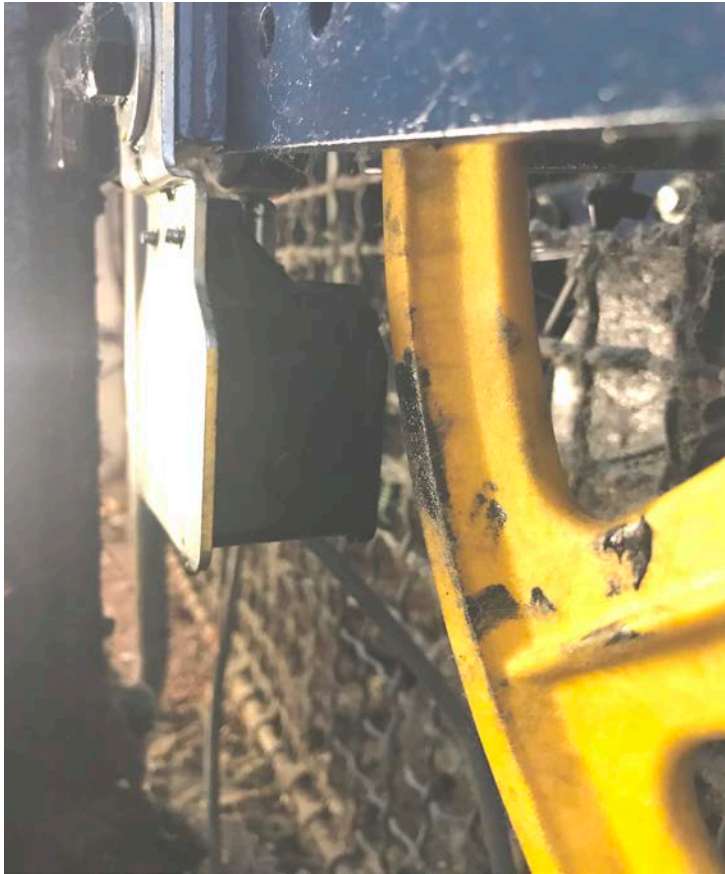
- 4.13 Without any site records to refer to it is suspected that this fault may have been due to the overspeed governor tension weight activating the slack rope switch in the lift pit.
- 4.14 Whatever the actual cause of the 'Safety Line Broken' fault the response, diagnosis and rectification of the fault by the lift contractor was extremely poor.
- 4.15 The Ground floor lock release of Lift No1 within Munden View should be repaired/replaced to enable authorised personnel ease of access.
- 4.16 The overhead diverter to Munden View Lift No2 should be inspected/investigated as it thought a slight rumbling may be emanating from the bearings.
- 4.17 The ride quality of the Munden View Lift No2 could be improved marginally.
- 4.18 The general standard of house and record keeping is very poor and not acceptable irrespective of any Contract conditions.

Without any site records to refer to it is suspected that the 'Safety Line Broken' fault may have been due to the overspeed governor tension weight activating the slack rope switch in the lift pit of Munden View Lift No2.

Although this fault has now been cleared it is considered the switch of Lift No2 could be afforded further clearance and the other three tension weights checked and adjusted accordingly.
